State of Nevada  
Department of Corrections  
Ely State Prison  
Facility Condition Analysis

# ELY STATE PRISON

**STATE OF NEVADA PUBLIC WORKS BOARD  
FACILITY CONDITION ANALYSIS**

Report Printed in January 2008

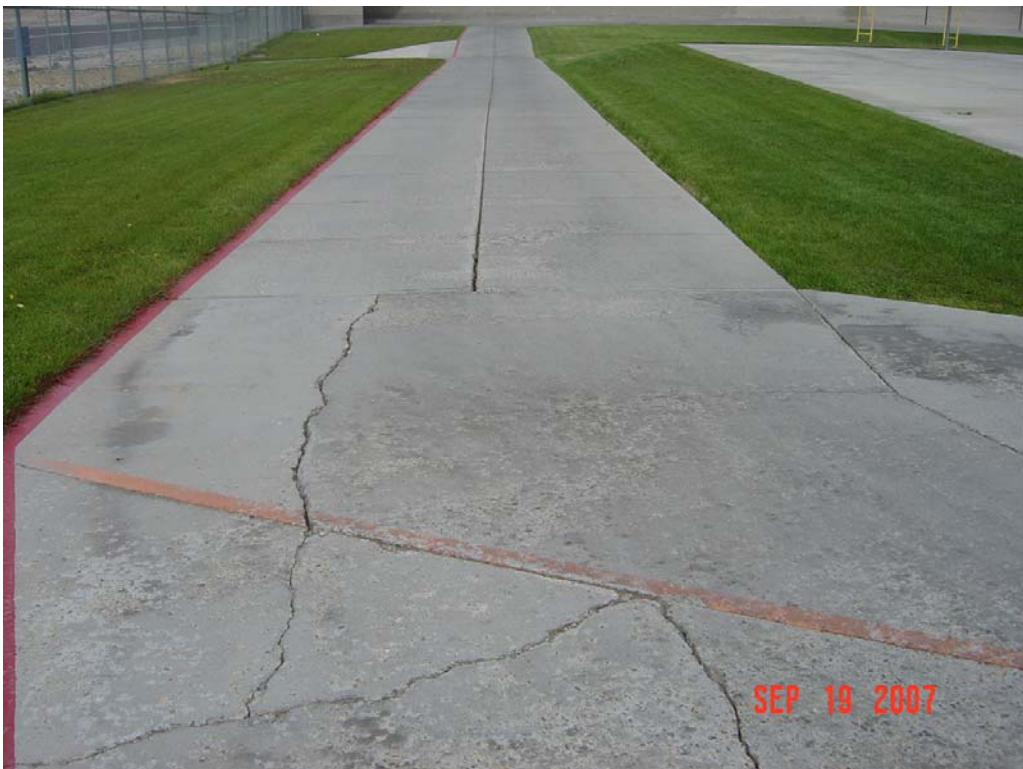
The concrete sidewalks are in generally good condition, but there are several areas that require attention. Deterioration, spalling and cracking has occurred, mainly from exposure to the weather. In some areas the sidewalks have lost their texture and cause a slipping hazard. This project would provide for the removal and replacement of the damaged concrete sidewalks. 5,000 SF of 4" thick concrete sidewalk was used for this estimate.

Ely State Prison - Site #9941  
Description: Damaged concrete walkway.

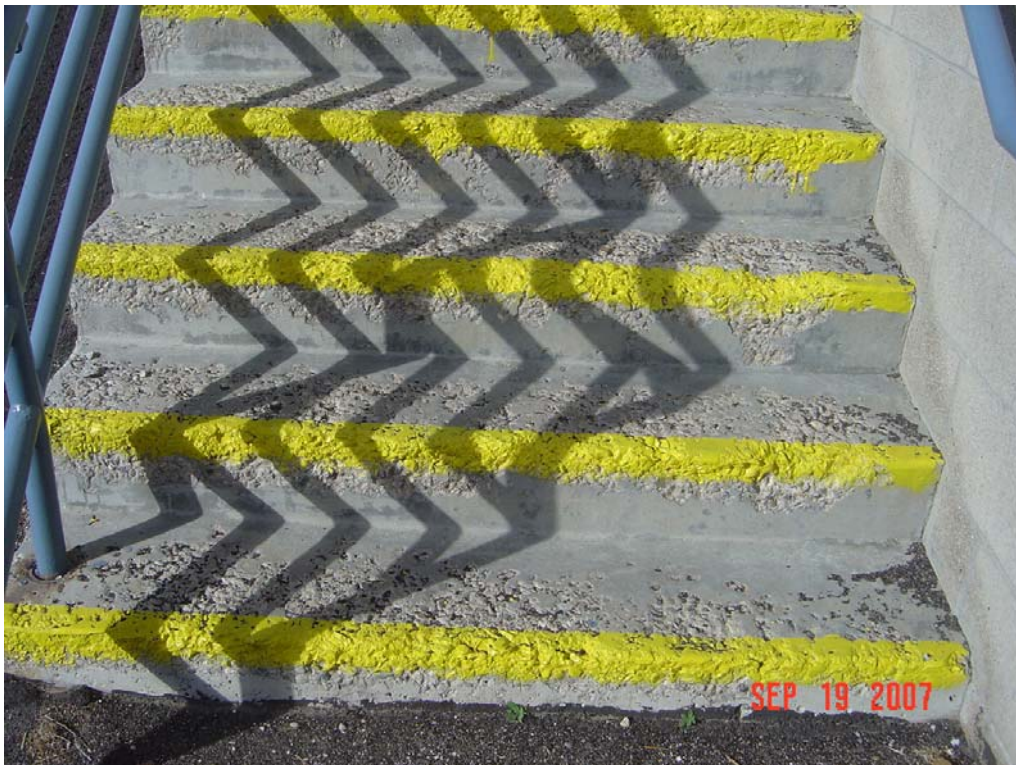
Building #11 – Warehouse / Central Plant - Building #1425  
Description: Exterior stairs damaged by weather.

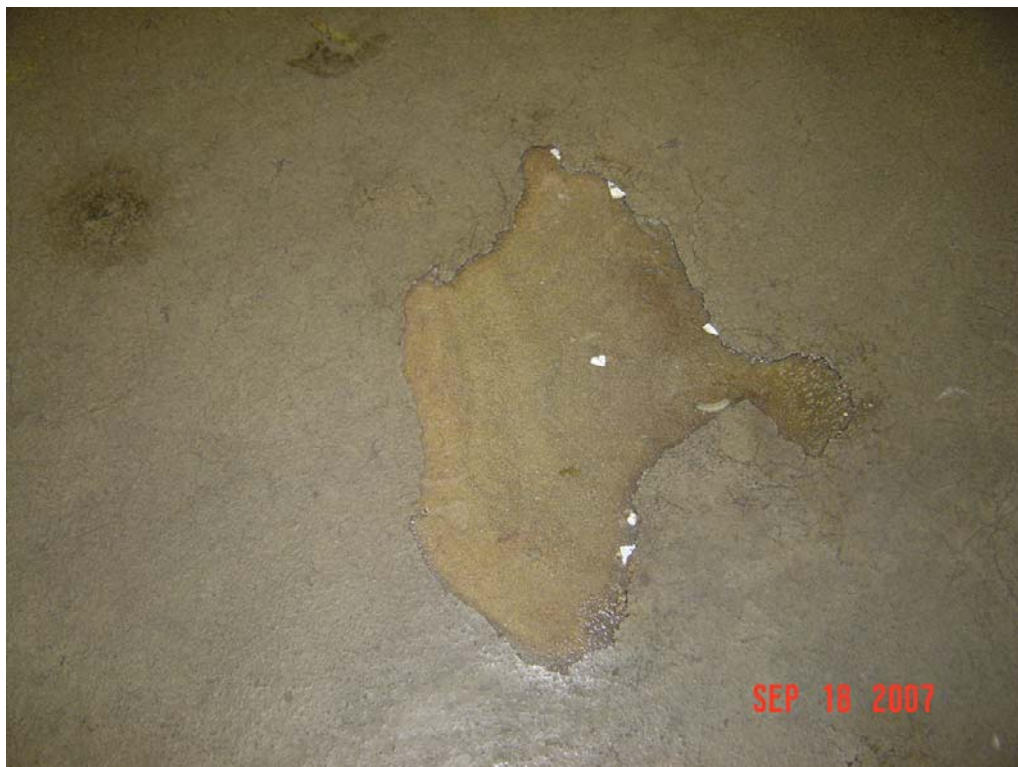
Building #10 – Work & Recreation - Building #1424  
Description: Damaged culinary floor.

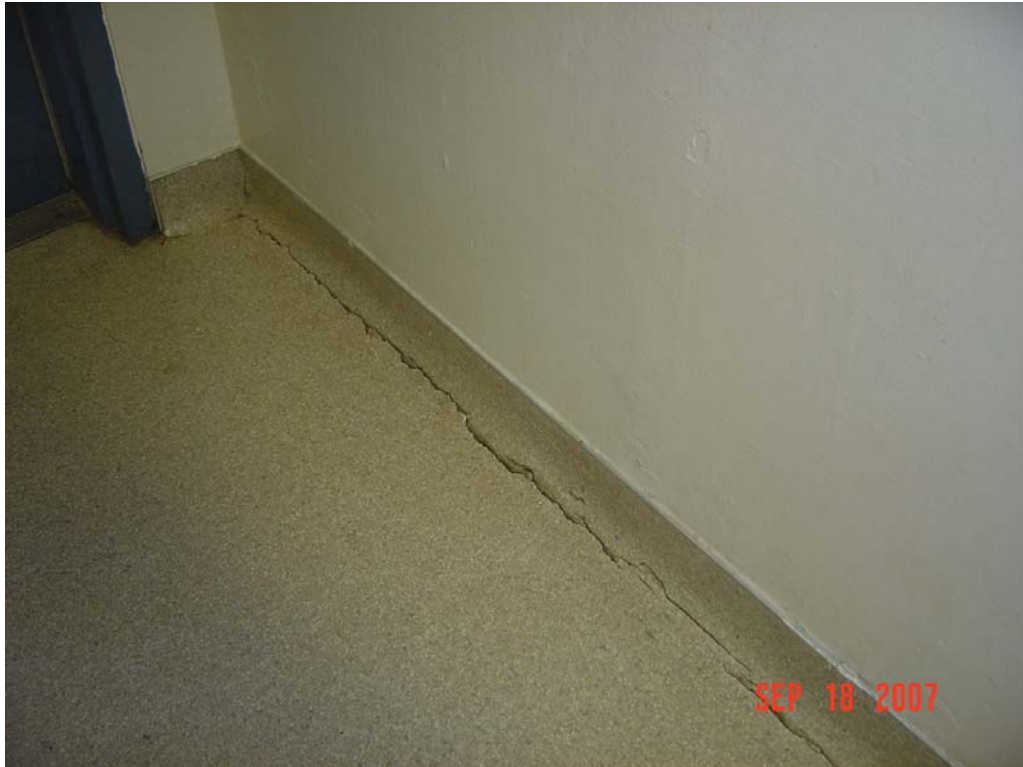
Building #9 – Scheduled Services - Building #1423  
Description: Damaged vinyl sheet in the infirmary area.

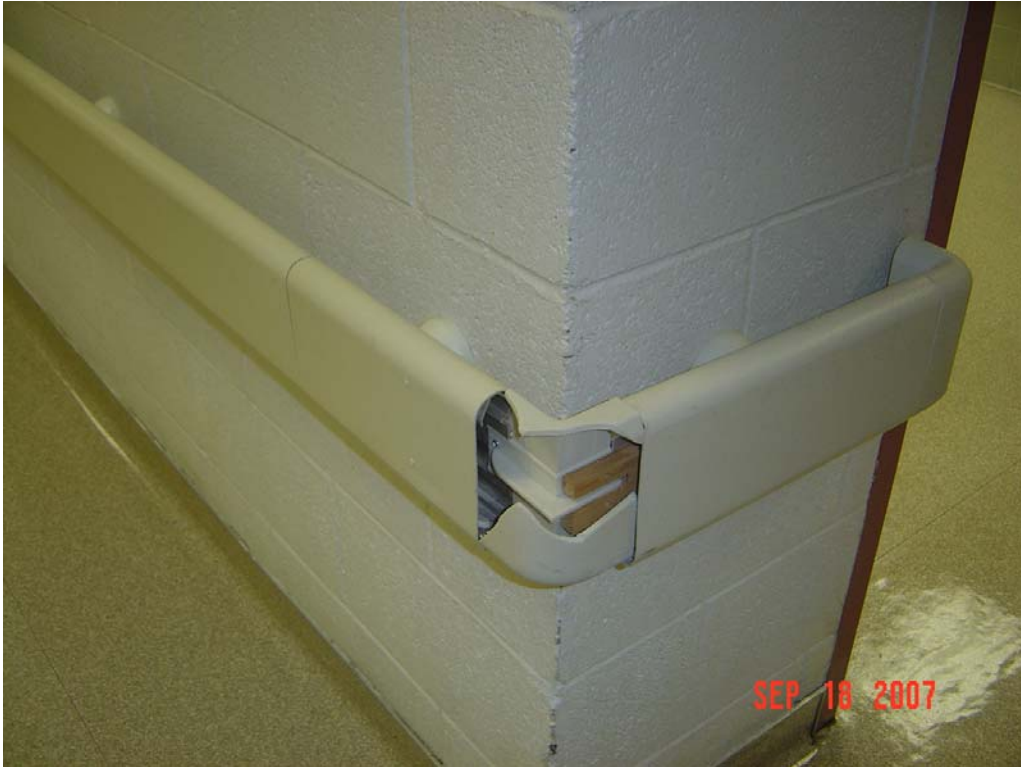
Building #9 – Scheduled Services - Building #1423  
Description: Damaged chair railing.

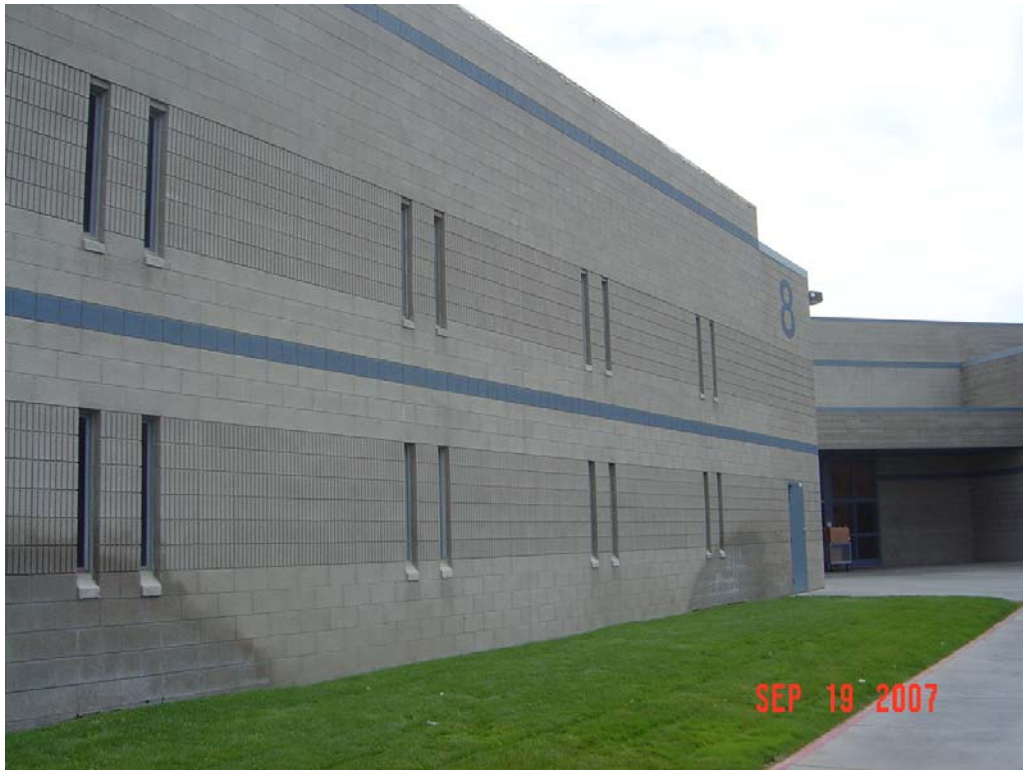
The existing irrigation system is spraying water on the side of the buildings inside the secured area, especially during windy conditions. There is noticeable damage to the exterior walls which can lead to extreme damage and possible mold growth if not addressed soon. This project would provide for the relocation of the sprinklers away from the buildings.

Housing Unit #8 - Building #1422  
Description: Exterior of the building, note water damaged walls.

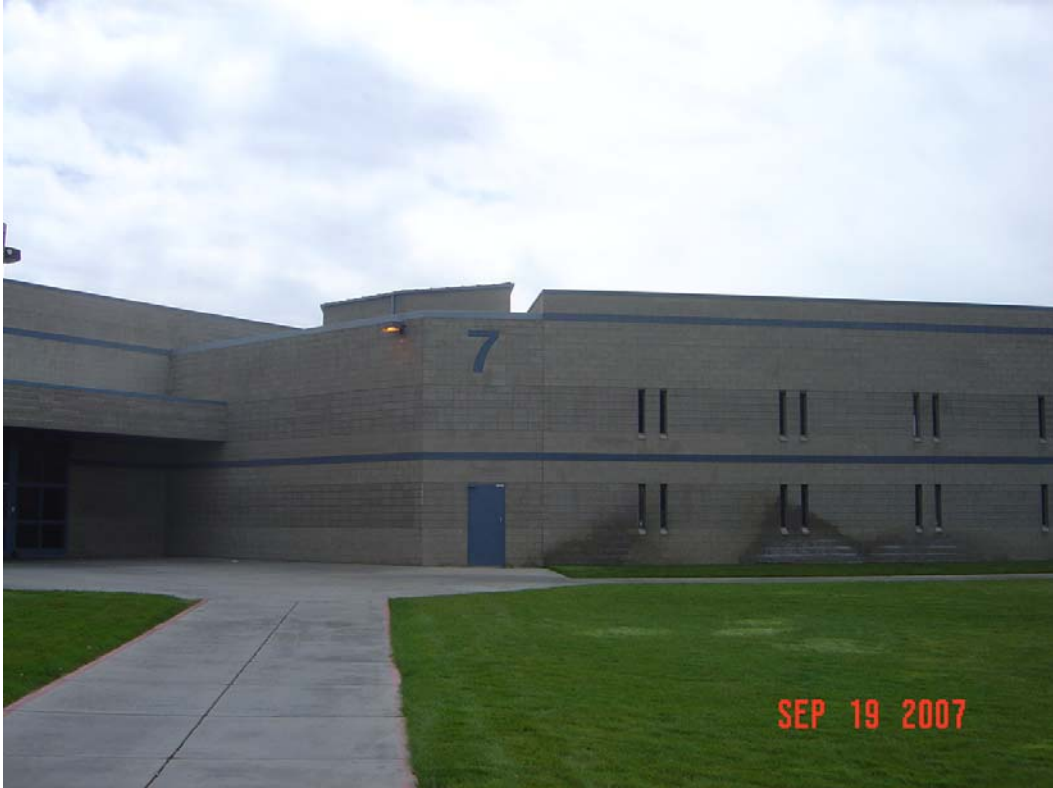
Housing Unit #7 - Building #1421  
Description: Exterior of the building, note water damaged walls.

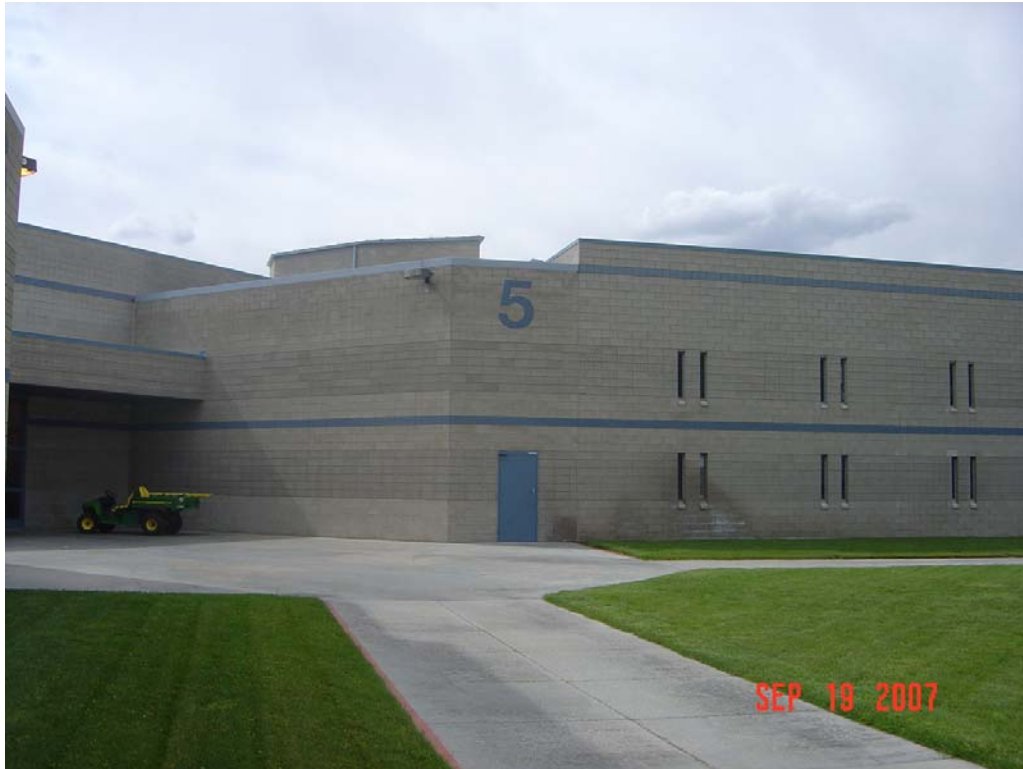
Housing Unit #5 - Building #1419  
Description: Exterior of the building, note water damaged walls.

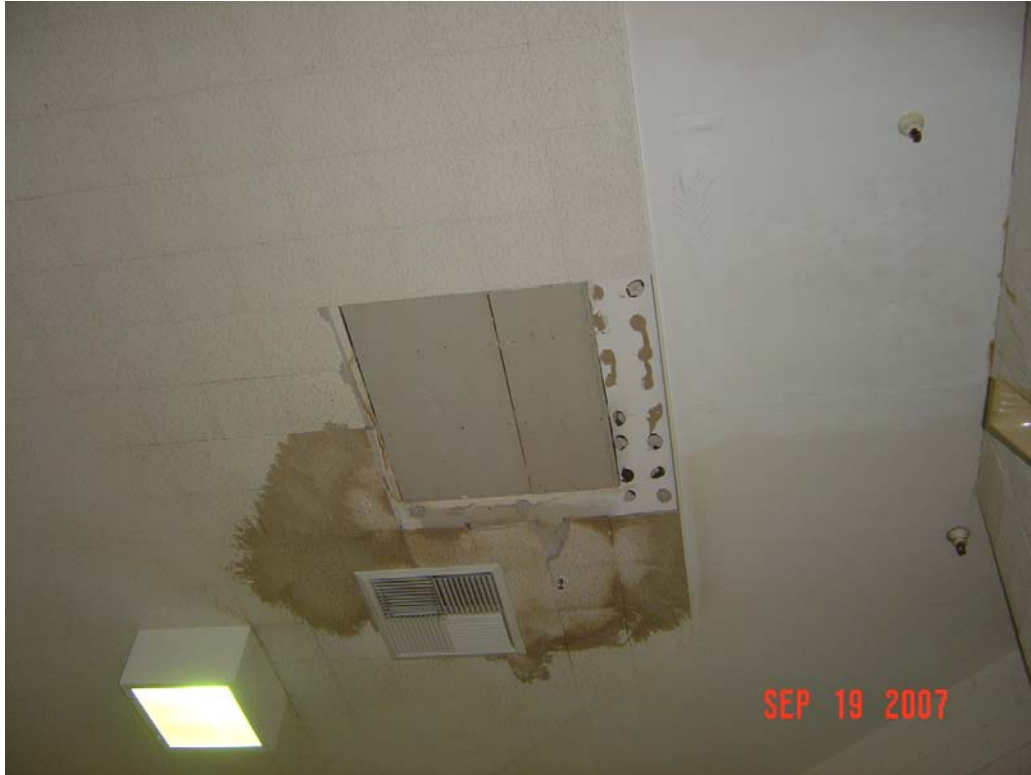
Housing Unit #5 - Building #1419  
Description: Water damaged ceiling tiles.

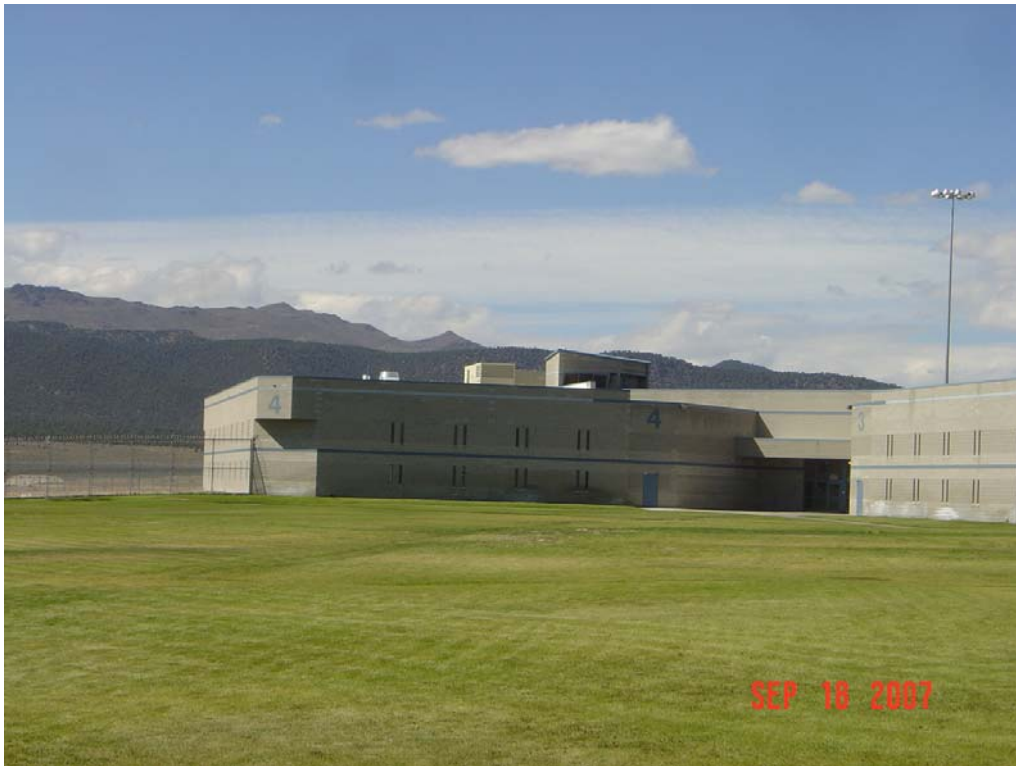
Housing Unit #4 - Building #1418  
Description: Exterior of the building, note water damaged walls.

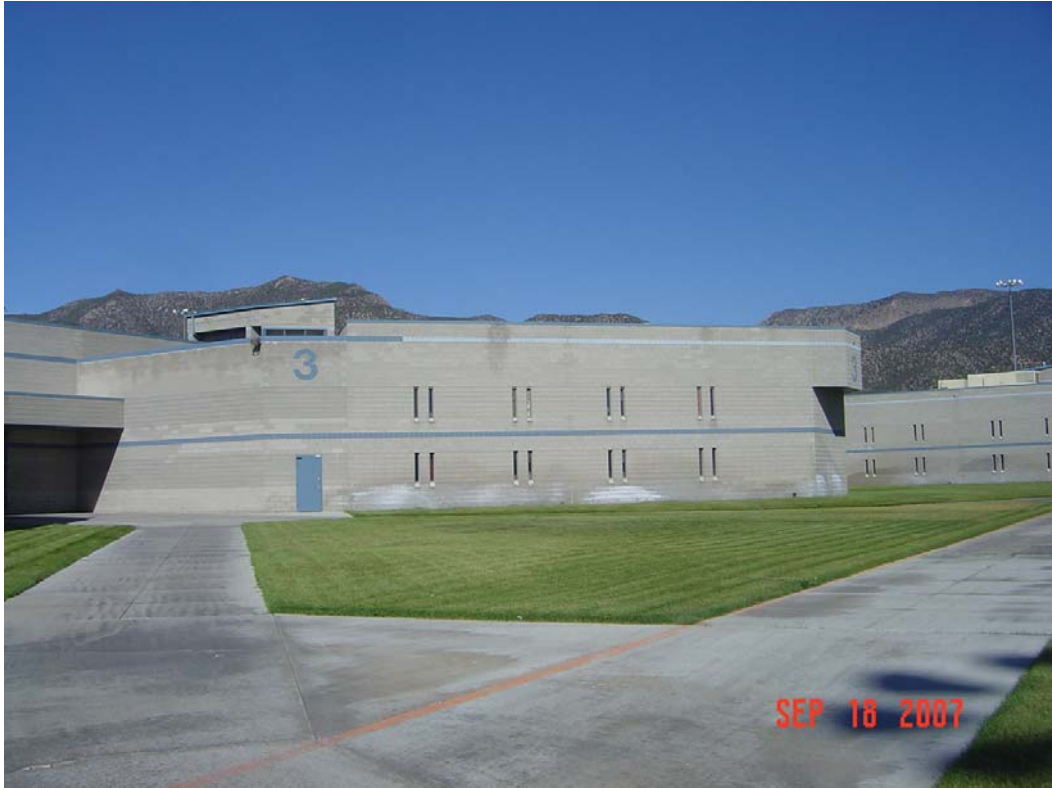
Housing Unit #3 - Building #1417  
Description: Exterior of the building, note water damaged walls.

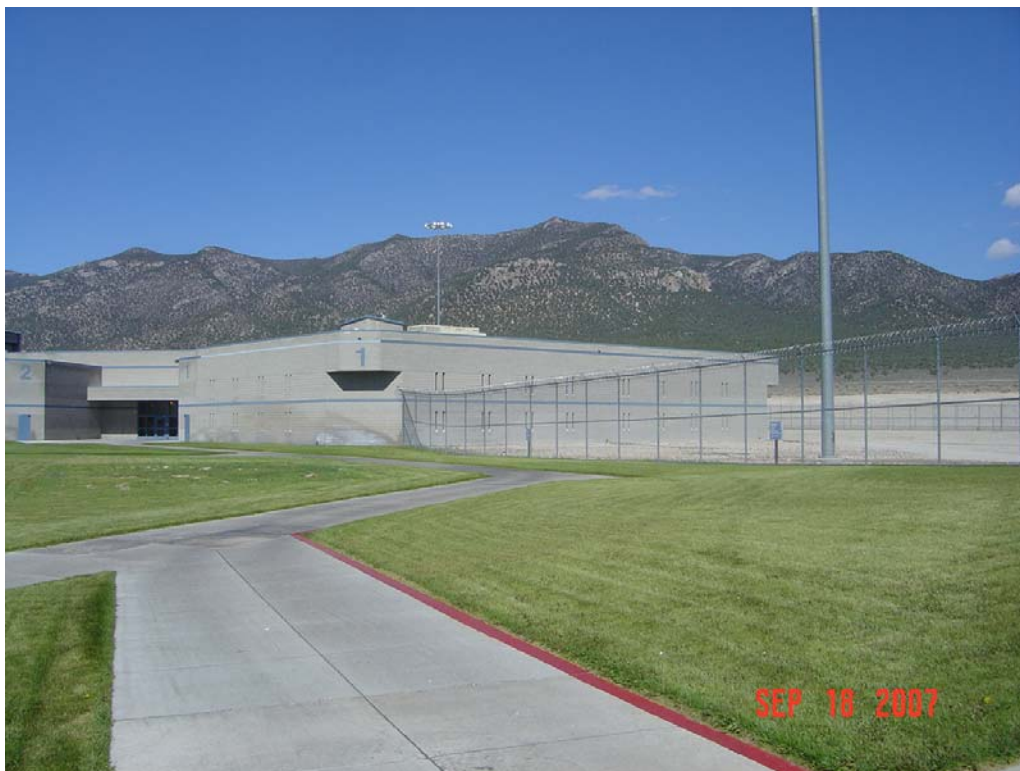
Housing Unit #1 - Building #0699  
Description: Exterior of the building, note water damaged walls.

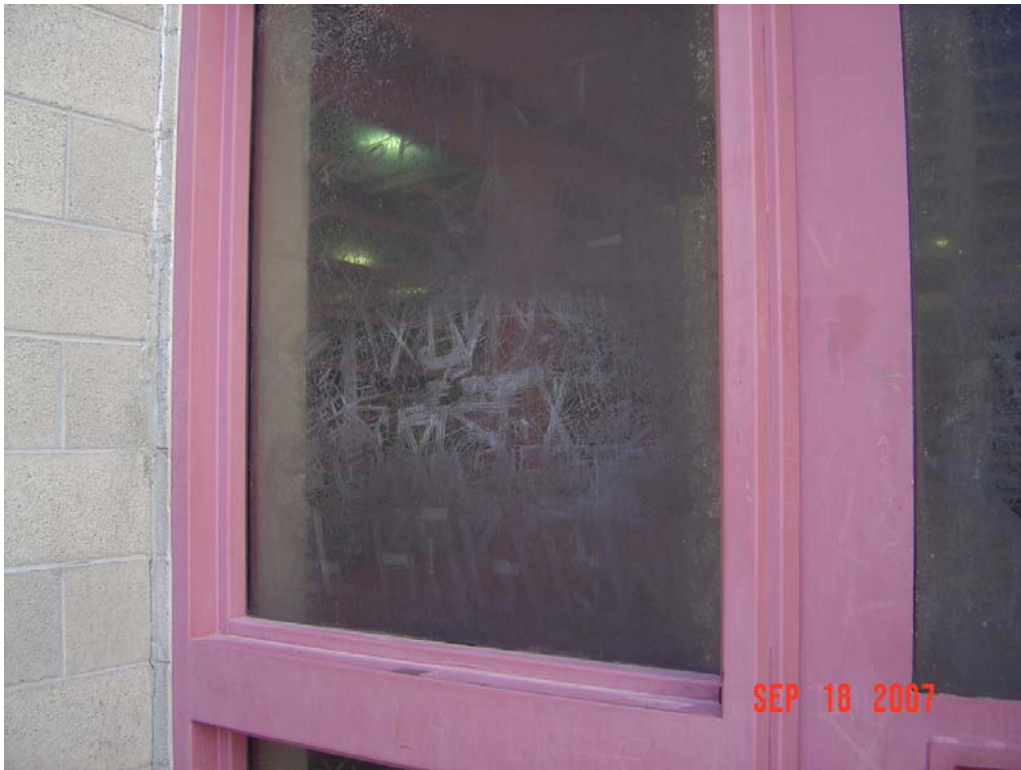
Housing Unit #1 - Building #0699  
Description: Damaged safety glazing at exercise yard.

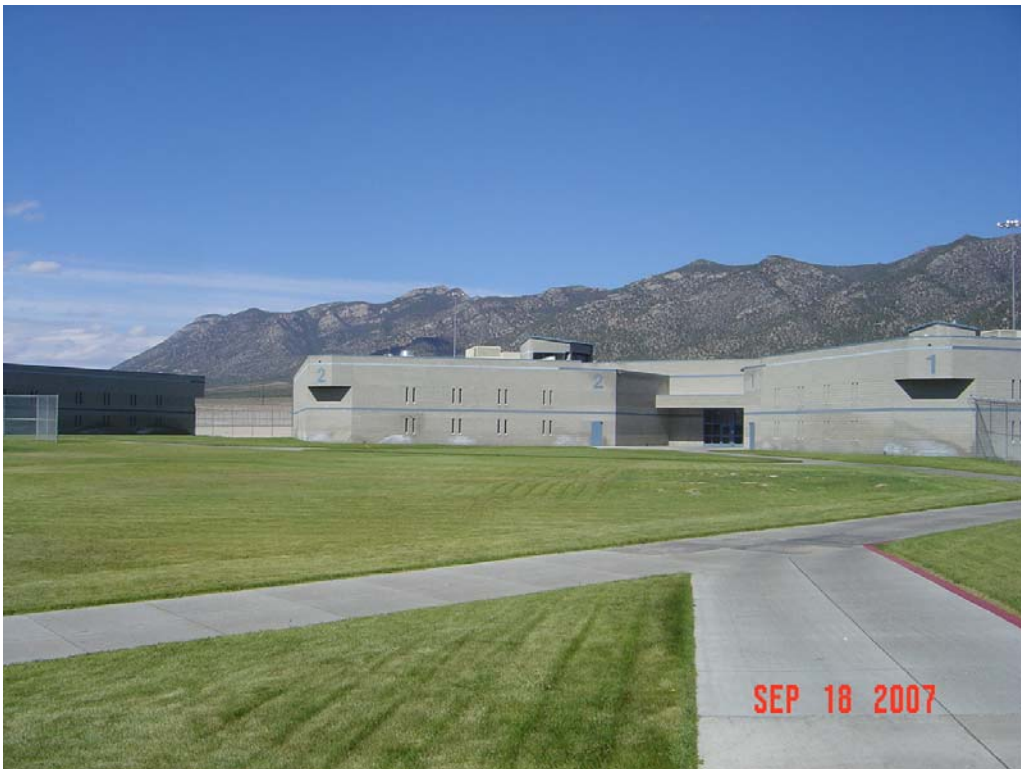
Housing Unit #2 - Building #0123  
Description: Exterior of the building, note water damaged walls.

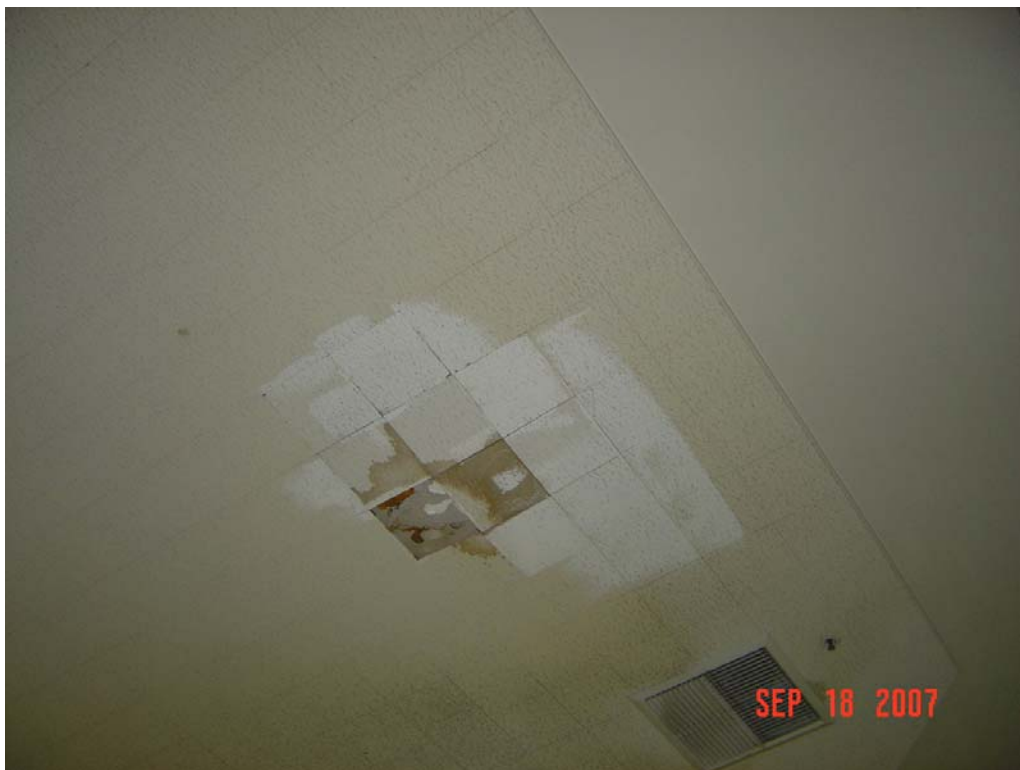
Housing Unit #2 - Building #0123  
Description: Damaged ceiling tiles.
